**Institution of Civil Engineering
Surveyors**

**M92 CARRIAGEWAY
RESURFACING AND
JUNCTION INSTALLATION
PROJECT**

EXPERIENCE REPORT

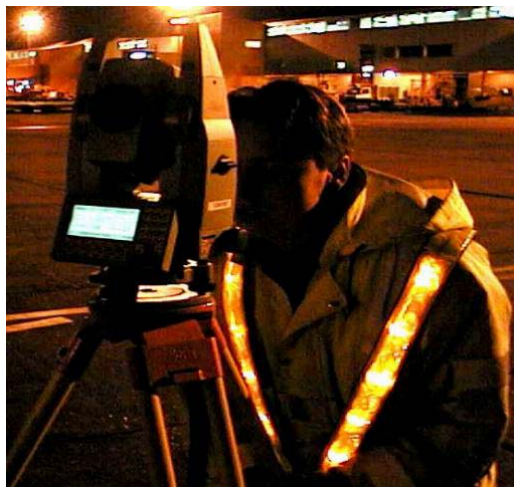
Figure 1 - flashing LED vests

Due to the confidential nature of the company's financial arrangements with the Highways Agency, financial information cannot be disclosed to third parties. However, when pricing of the project, additional factors had to be incorporated into the pricing structure to allow for extraneous risk / cost implications. Such as investment in Leica TCRA professional tracking theodolites (being on their field trials for the first time), additional insurance and Personnel Protective Equipment (PPE) e.g. flashing LED vests (see figure 1).

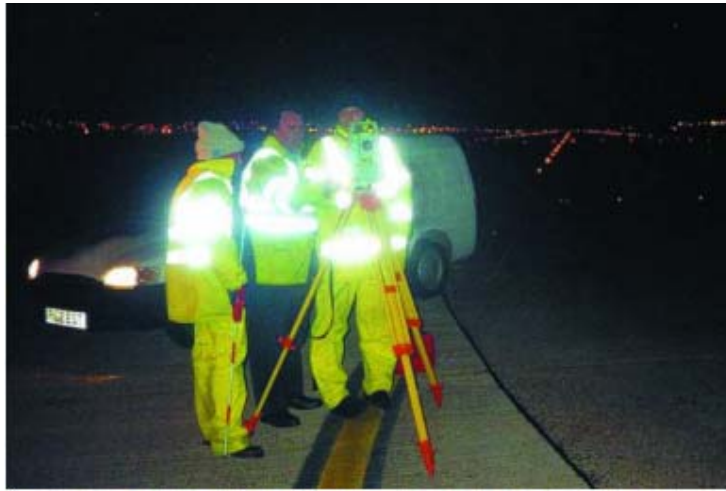
A choice of total station instruments was considered, which could overcome point 1) The benefit of using TCRA's (see figure 2) over conventional total stations, was that during the night surveys, the instrument man only had to point the viewfinder in the approximate direction of the prism. The automatic target recognition (ATR) function accurately located and recorded the centre of the prism. This increased the speed and accuracy achieving approximately 1000 points / team / shift. The TCRA instruments were established and marked on the centre line of the carriageway, opposite a PGM. Multiple observations were taken (both faces) to mini-prism pogos on 2 or 3 PGM's (See Appendix E). Additional reference observations were taken to remote objects to enable regular angular checks to be made during the night without the need to revisit PGM's.

Figure 2 - TCRA on carriageway

The TCRA's also had an active tracking facility, which followed the prism and constantly updated the distance measurements, while the 'detail man' walked between survey points. The instrument man only needed to press the record button to take the observation. This increased observational rates up to 1500 points / team / shift increasing productivity by 50%.

Quality control checks highlighted errors in the TCRA's tracking mode. Although the instrument correctly followed the prism and recording during rapid angular movements, real-time updates to the distances were not achieved. (The TCRA recorded the correct angles but not true distances.) The manufacturer was immediately informed of the problems and survey procedure reverted to ATR (which enabled improved performance over traditional survey instruments).

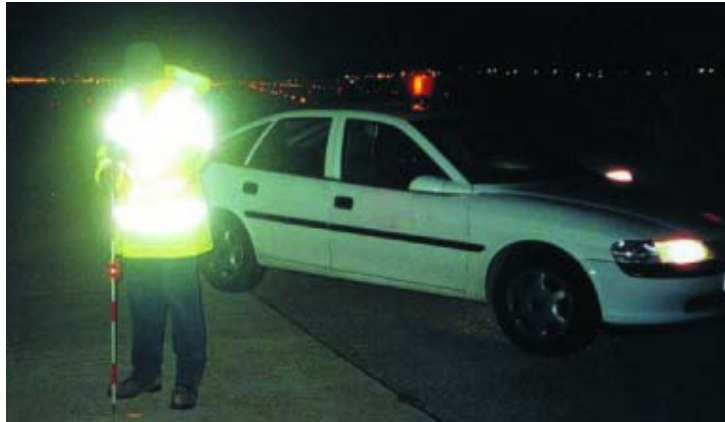
Figure 3 - surveying the cross-sections.

Before any cross-sections could commence, the 25 metre cross section reference points had to be set out on the outer edges of each carriageway. This provided an accurate perpendicular line for the 5-metre cross-section survey. In practice this method failed as surveyors found it difficult to trace the perpendicular line at night.

The solution involved using lights on the marks along the carriageway shoulders, with a third light on the carriageway centreline. Surveyors then used these reference lights to maintain the perpendicular lines while observing the cross-sections.
